**Traditional Reserve Study
For
Sand Lake Point Homeowners Association, Inc.
Orlando, Florida
February 7, 2024**

Report Number: 2024.02.07.203

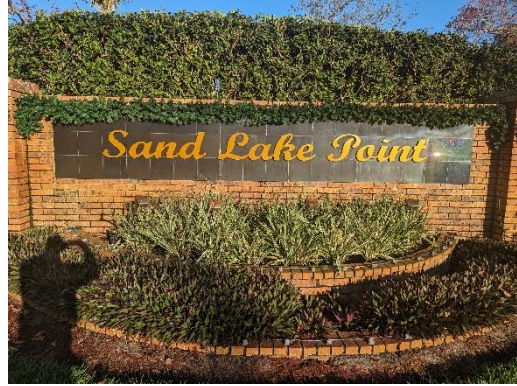
ID: 001

- **Entrance Signage** – There are 6 entrance signs. They appear to be fading slightly but overall, in fair condition.
- **Fencing, Chain Link** – There is approximately 1,410 linear feet of chain link fence. It is damaged, sagging and leaning. It is in poor condition.

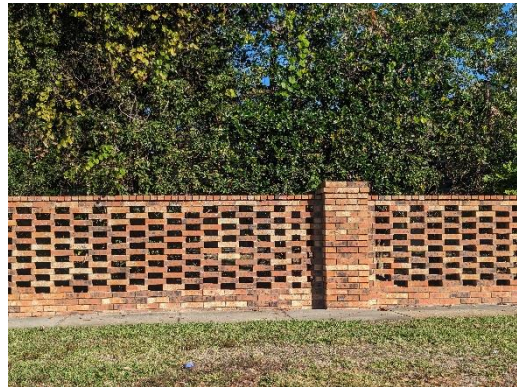
ID: 002

- **Perimeter Wall, Brick** – There are approximately 15,210 square feet of brick perimeter wall. It appears to be in good condition.
- **Recessed Mailboxes, Partial** – There are 11 recessed mailboxes. They appear to be in very good condition. The estimated remaining useful life is 40 years and so the total replacement cost is excluded from the study. A periodic failure rate of 5% every 3 years is included in the study as the estimated costs are significant.

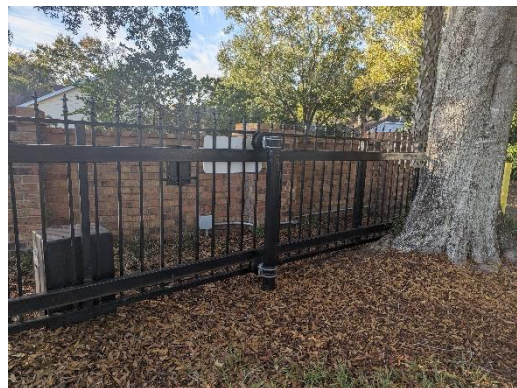
ID: 003

- **Emergency Landscaping Expense** – This was added at the direction of the board.
- **Entrance Gate** – There is one 33-foot metal entrance gate. It is showing signs of rust. It is in fair condition.

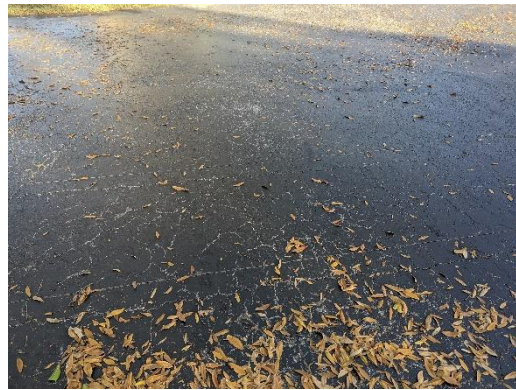
ID: 005

- **Asphalt Pavement, Crack Repair Seal and Coat** – There is approximately 3,397 square yards of asphalt pavement. The sealant is in fair condition.
- **Asphalt Pavement, Mill and Overlay** – There is approximately 3,397 square yards of asphalt pavement. There is moderate cracking throughout and some areas that have heavy cracking due to tree roots. It is in poor condition. Third party vendors may charge a higher mobilization fee because of the small amount of asphalt. This can vary from vendor to vendor, so we recommend getting a third-party quote.
- **Cluster Mailboxes, Partial** – There are 14 full-size cluster mailboxes between the mailbox station and on Lake Cromwell. They appear to be in very good condition. The estimated

The Association may be able to mill and overlay the asphalt pavement prior to replacement. Milling and overlaying asphalt pavement is significantly less expensive than replacement, with approximately the same useful life if the asphalt pavement is maintained properly.

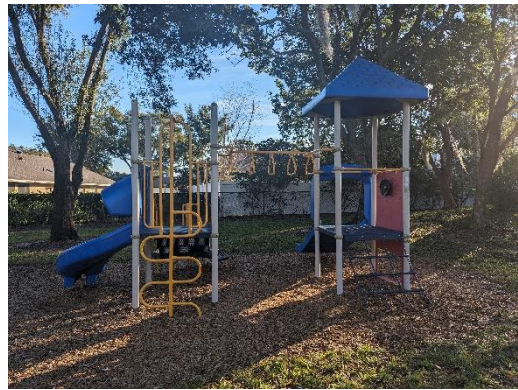
ID: 008

- **Playground Equipment, Allowance** – There is one playground and one swing set. They appear to be in good condition.
- **Tennis Court Fencing, Chain Link** – There is approximately 440 linear feet of 10-foot chain link fence. Although it is in fair condition, it is typically replaced during the tennis court replacement process.
- **Tennis Court, Replacement** – There is one double tennis court. It has a foundational cracking. It is in poor condition.
- **Tennis Court, Resurfacing** – There is one double tennis court. It has a foundational cracking. It is in poor condition.

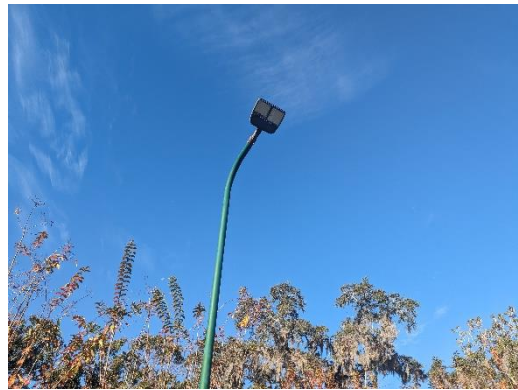
ID: 011

- **LED Lights** – There are 18 LED lights between the tennis courts and the clubhouse area. They appear to be in fair condition.
- **Light Poles** – There are 12 light poles between the tennis courts and the clubhouse area. They appear to be in good condition.

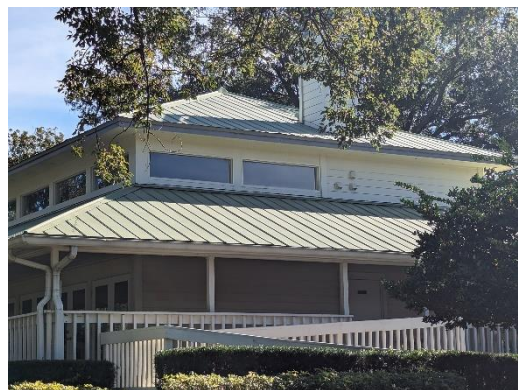
ID: 012

- **Roof, Metal** – There are approximately 42 squares of metal roof. It appears to be bent at the eaves and has a leak. It is in poor condition.
- **Windows, Allowance** – This allowance provides for the replacement of the windows. They appear to be in fair condition.

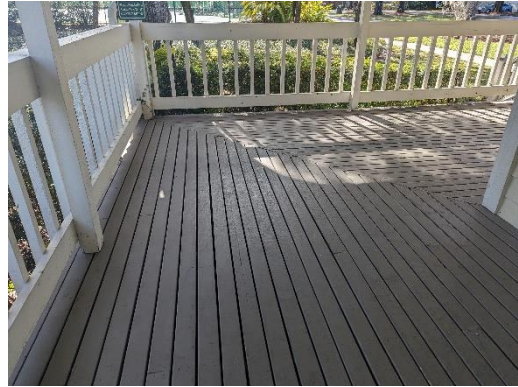
ID: 013

- **Decking** – There are approximately 1,422 square feet of decking around the clubhouse. It appears to be in fair condition.
- **Doors, Allowance** – This allowance provides for the replacement of the doors. They are in excellent condition.

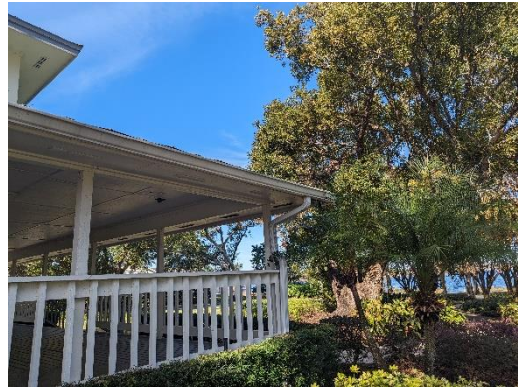
ID: 014

- **Gutters and Downspouts** – There are approximately 292 linear feet of gutters and downspouts. They are in poor condition.
- **HVAC** – There is one 4-ton Goodman HVAC unit. It is in fair condition.

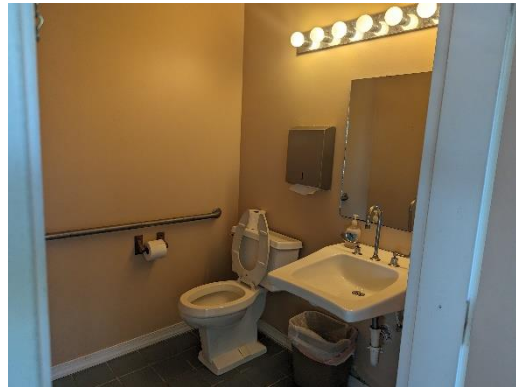
ID: 016

- **Bathrooms** – There are two bathrooms in the clubhouse. They appear to be in fair condition.
- **Clubhouse Replacement Fund, Partial** – This allowance provides for the replacement of the clubhouse. Added at the direction of the board. The estimated remaining useful life is 100 years and so the total replacement cost is excluded from the study. A periodic failure rate of 5% every 3 years is included in the study as the estimated costs are significant.

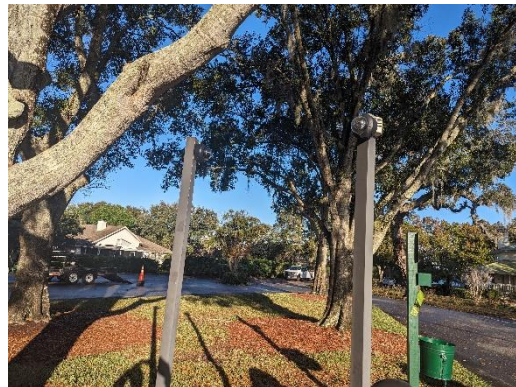
ID: 017

- **Security Camera System** – There are approximately 9 security cameras. They appear to be in good condition.
- **Sidewalks, Concrete, Partial** – There are approximately 2,950 square feet of concrete sidewalks between the mailbox station and the clubhouse area. There is some severe cracking in front of the clubhouse, but overall, it is in good condition. The estimated remaining useful life is 65 years and so the total replacement cost is excluded from the study. A periodic failure rate of 5% every 3 years is included in the study as the estimated costs are significant.

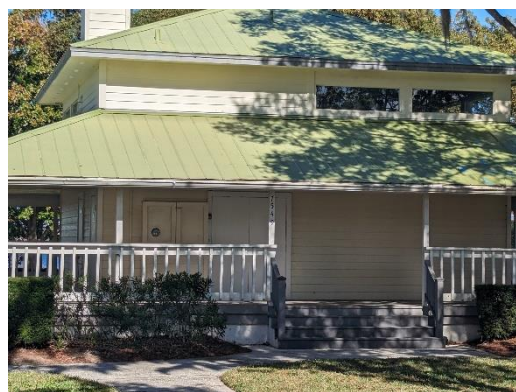
ID: 018

- **Exterior Painting** – There is approximately 6,498 square feet of exterior painting including the decking. It is in fair condition.
- **Flooring, Carpet** – There are approximately 418 square feet of carpet. There are many stains. It appears to be in fair condition.

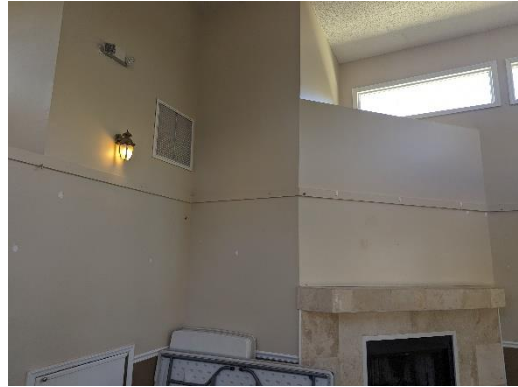
ID: 019

- **Interior Painting** – There are approximately 2,120 square feet of interior painting. It appears to be in fair condition.
- **Kitchen Remodeling** – This allowance provides for the replacement of the fridge, tile, and cabinets. They appear to be in good condition.

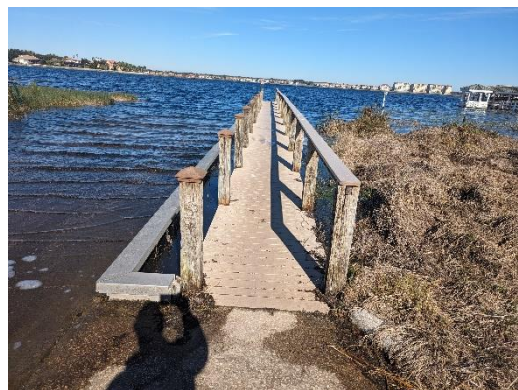
ID: 024

- **Dock, Replacement, Partial** – This provides for the removal of the dock and replacing the section damaged by the hurricane. The estimated remaining useful life is 40 years and so the total replacement cost is excluded from the study. A periodic failure rate of 5% every 3 years is included in the study as the estimated costs are significant.

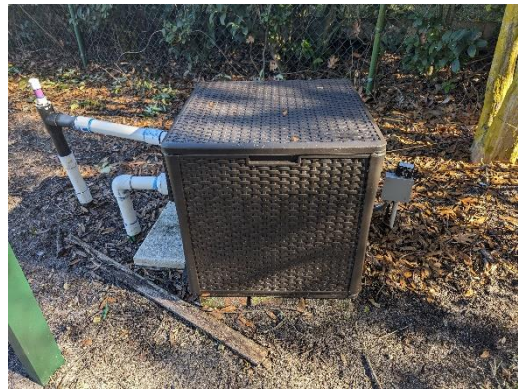
ID: 026

- **Irrigation, Allowance** – This allowance provides for the replacement of the irrigation pumps in the median and the clubhouse area. No condition assessment is available.

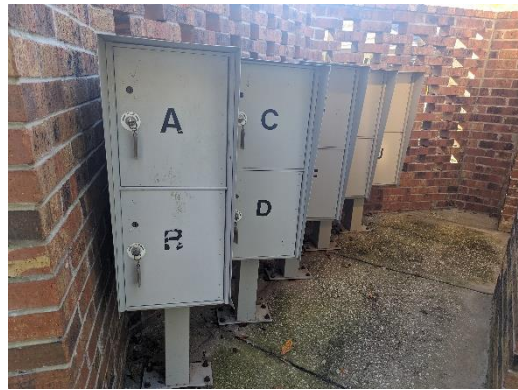
ID: 029

- **Parcel Mailboxes, Partial** – There are 10 parcel mailboxes. They appear to be in very good condition. The estimated remaining useful life is 40 years and so the total replacement cost is excluded from the study. A periodic failure rate of 5% every 3 years is included in the study as the estimated costs are significant.

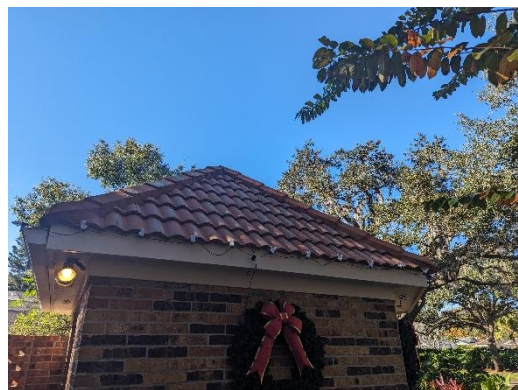
ID: 030

- **Brick, Repointing** – There are approximately 1,150 square feet of bricks. They appear to be in good condition.
- **Roof, Terracotta** – There are approximately 4 squares of terracotta roofing on the mailbox station. It appears to be in good condition.
